**PRELIMINARY ASSESSMENT/
VISUAL SITE INSPECTION**

**REXWORKS, INC.
MILWAUKEE, WI
WID 000 809 137**

FINAL REPORT

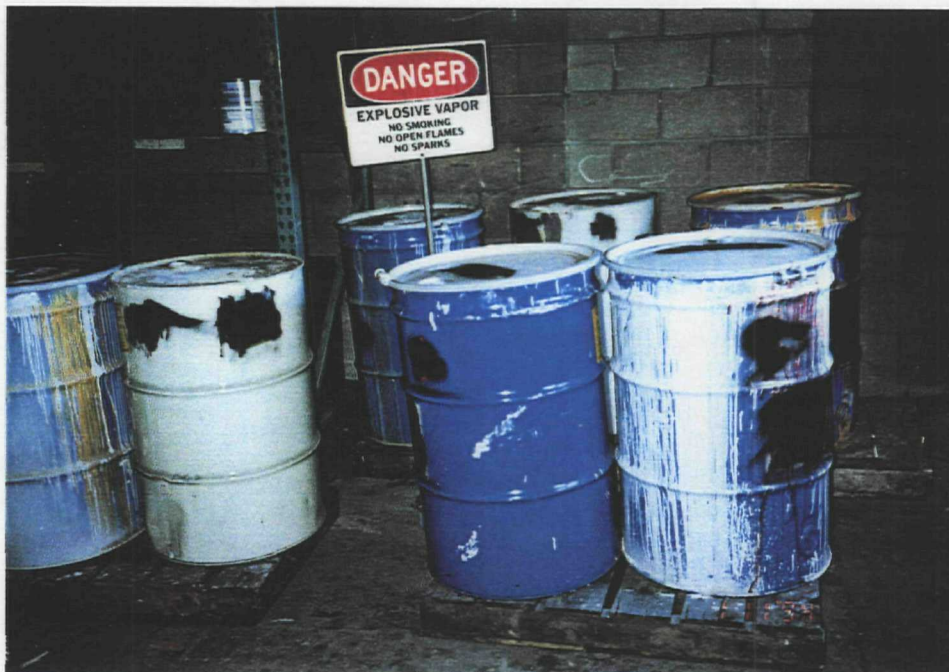
Photograph No. 1 (No. 5 in field notes)

Observations: During the VSI, the unit contained three drums of waste thinners (D001); four drums of waste paints (D001); one drum of diesel fuel-contaminated groundwater (D001); one rusted drum of nonhazardous waste grease; four drums of nonhazardous used oil; and two drums of monitoring well groundwater (unknown) from quarterly sampling activities at the Former USTs (AOC 1) awaiting characterization. PRC noted no evidence of release (see Photographs No. 1 and 2).

Description: Drums of wastes are stored on wooden pallets on the concrete floor of this unit. Shown in the photograph are three drums of waste thinners (D001) and four drums of waste paints (D001).

Recommendations: PRC recommends no further action for this SWMU at this time.

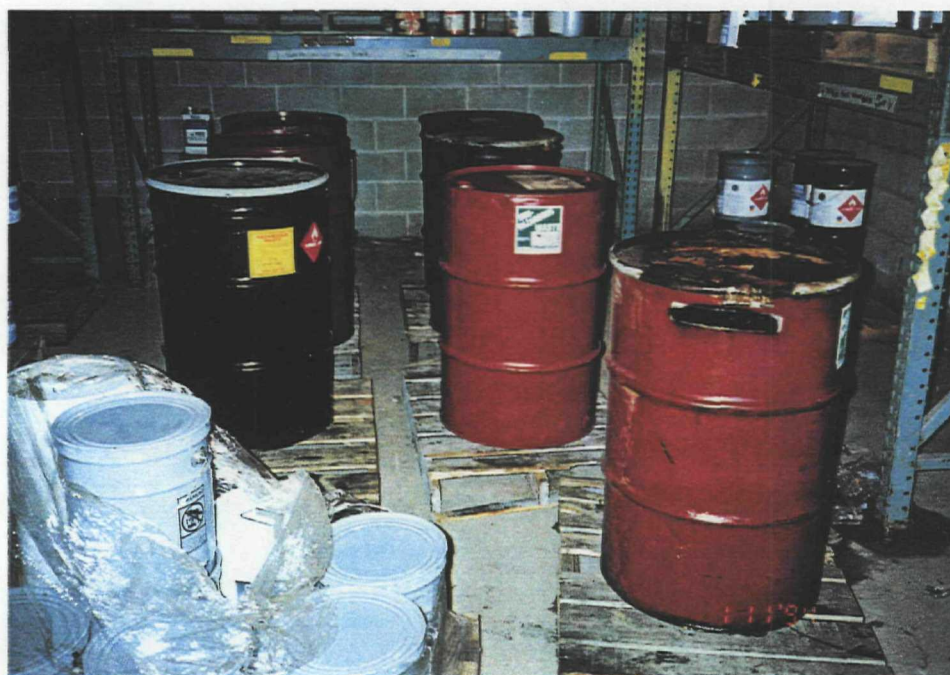
Photograph No. 2 (No. 4 in field notes)

Description: Drums of wastes are stored on wooden pallets on the concrete floor of this unit. Shown in the photograph are one drum of diesel fuel-contaminated groundwater (D001), one rusted drum of nonhazardous waste grease, four drums of nonhazardous used hydraulic oil, and two drums of groundwater from quarterly sampling.

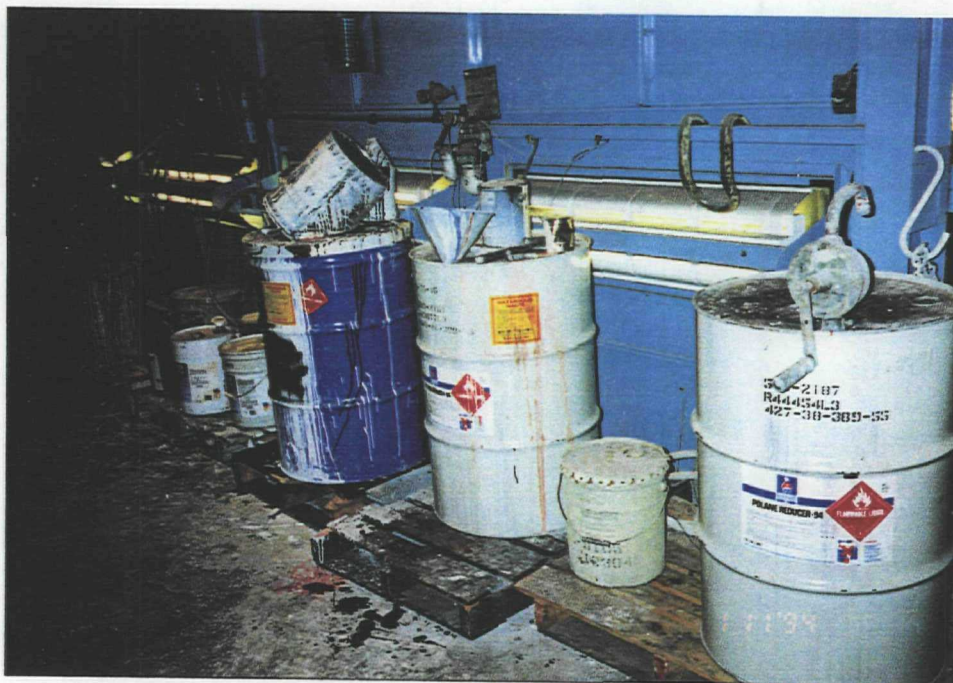
Photograph No. 3 (No. 2 in field notes)

During the VSI, several of the SAA drums were uncovered when not in use. Paint stains were observed on the waste drums and on the concrete floor below the unit. Several drums of wastes were not stored covered (see Photographs No. 3 and 4).

Conclusions: The unit is located indoors. Drums of waste are stored open. Drums of waste are stored on wooden pallets or metal casters on the concrete floor. No floor drains are located near the SAAs. Paint stains were observed on the waste drums and on the concrete floor below the unit. The potential for release to groundwater, surface water, air, and on-site soils is low.

Description: This photograph is of the SAA at paint booth No. 4. Empty paint pails are allowed to drain into the blue drum of waste paints (D001). Waste thinners (D001) are transferred into the white drum from a 5-gallon pail via a plastic funnel. Note paint stains on the floor.

Recommendations: PRC recommends the facility close the drums when they are not being filled.

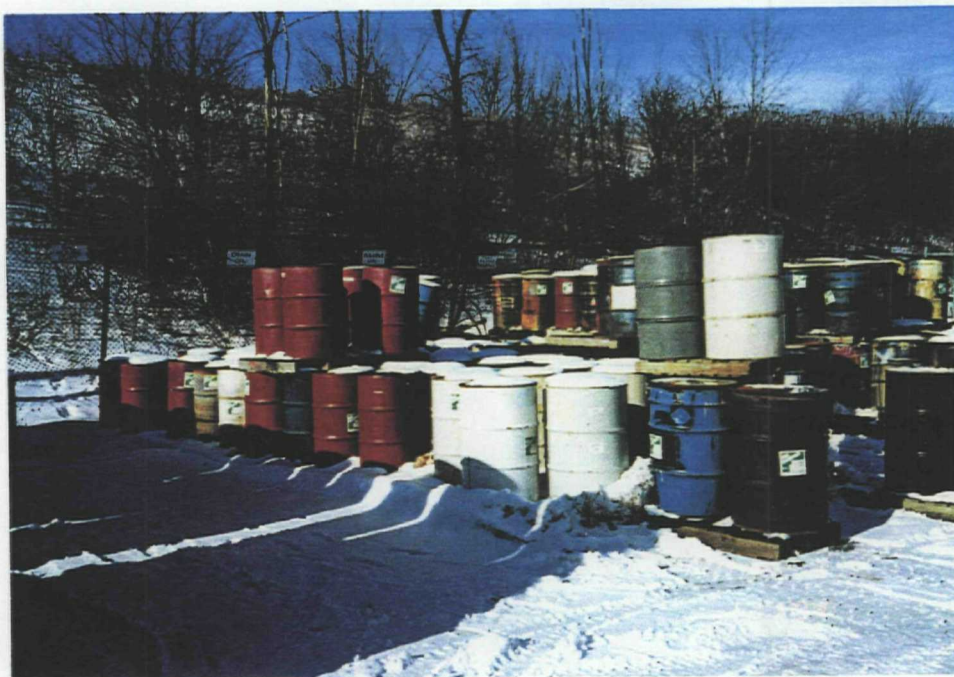
Photograph No. 5 (No. 8 in field notes)

Observations: During the VSI, the unit contained many drums. Some drums were rusted, and drums that contained waste paint filters and water were bulging because of the extreme cold. PRC noted no evidence of release (see Photographs No. 5 and 6).

PRC recommends that the facility implement release controls (such as concrete curbs) to prevent a release from flowing into the storm sewer.

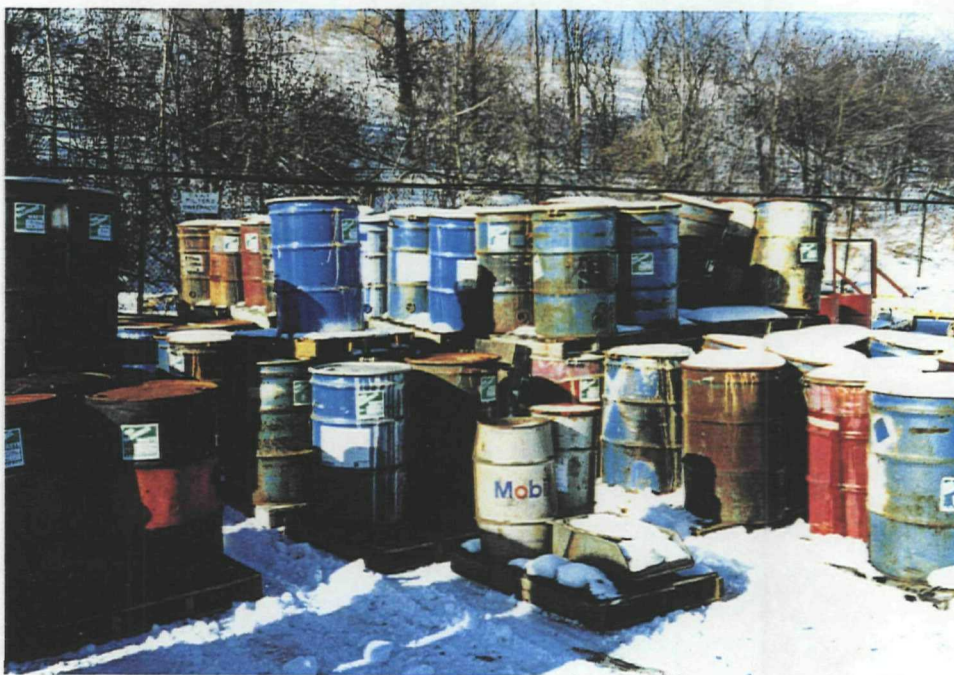
Photograph No. 6 (No. 9 in field notes)

Description: Note some drums are rusted, and drums of waste paint filters have bulging bottoms.

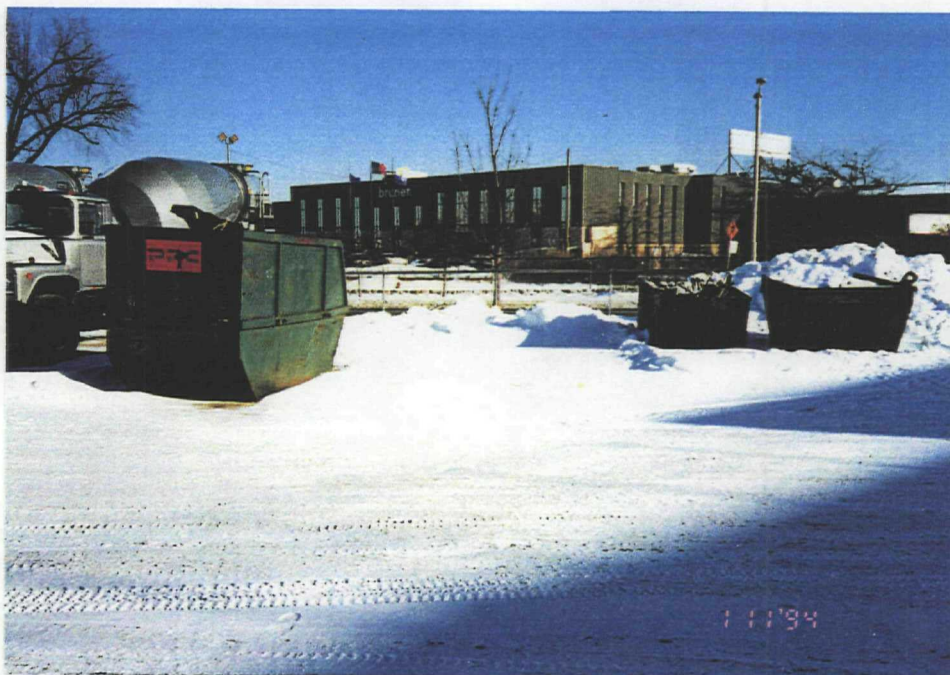
Photograph No. 7 (No. 1 in field notes)

Observations: During the VSI, three hoppers of scrap steel were being stored in the unit. PRC noted no evidence of release (see Photograph No. 7).

Description: Nonhazardous scrap steel is stored in this unit; primary scrap steel is stored in the 12-cubic-yard hopper on the left, and secondary scrap steel is stored in the 4-cubic-yard hoppers on the right.

PRC recommends no further action for this SWMU at this time.

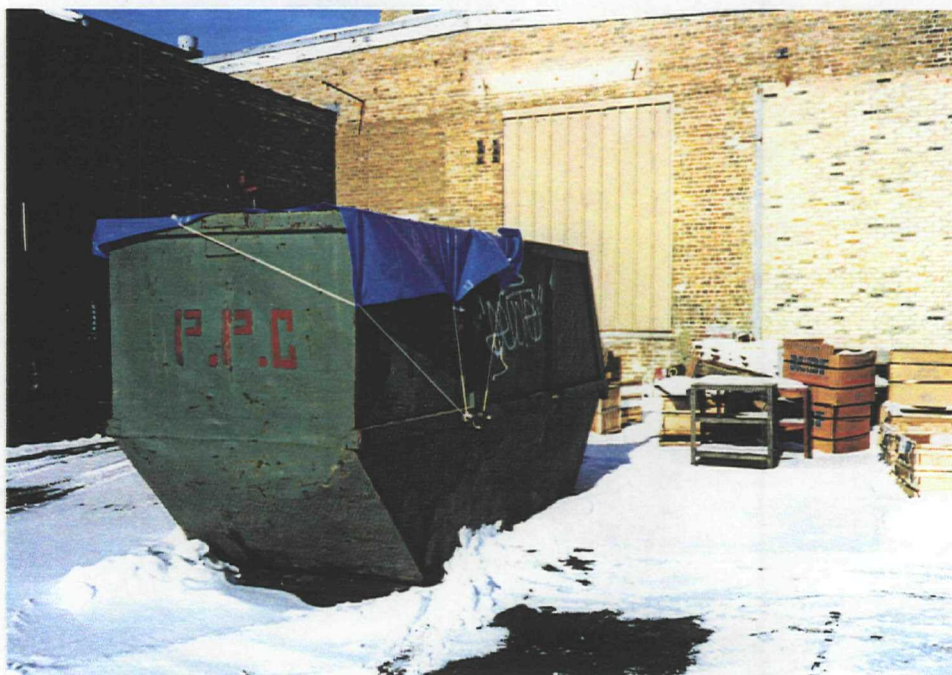
Photograph No. 8 (No. 7 in field notes)

Observations: During the VSI, the unit contained some machining chips and was covered with a tarp. PRC noted no evidence of release (see Photograph No. 8).

Description: Nonhazardous scrap steel from machining is stored in this unit.

Recommendations: PRC recommends no further action for this SWMU at this time.

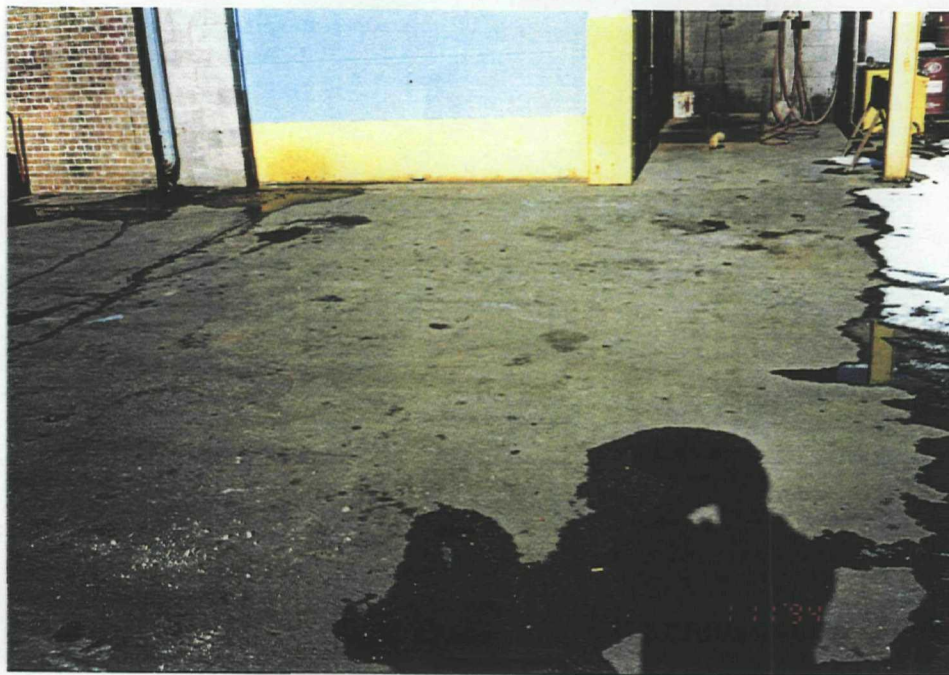
Photograph No. 10 (No. 10 in field notes)

This AOC consists of two active 32,000-gallon tanks that were installed in 1930. These tanks are constructed of concrete and have not been tested for leaks. The facility plans to install groundwater monitoring wells around this AOC in the spring of 1994 to determine if soils and groundwater have been affected. During filling operations in January 1986, about 250 gallons of No. 6 fuel oil was released to a sloped asphalt drive. An unknown amount of fuel oil entered a storm sewer drain and was discharged to the Kinnickinnic River as detailed in Section 2.4 (see Photograph No. 10).

Conclusions: This AOC consists of two active 32,000-gallon concrete tanks that were installed in 1930. These tanks have not been tested for leaks. During filling operations in January 1986, an unknown amount of No. 6 fuel oil was released to the Kinnickinnic River through an on-site storm sewer. The potential for release to environmental media is summarized below.

Recommendations: PRC recommends that the facility install groundwater monitoring wells around the tanks as planned.
